Inspection Report

Gerald Jones
1216 Drivers Cr
Rocky Top, NC

Atlantic Inspection Service
Residential & Commercial Inspection Services
(252) 903-3977 | Eddie Thornell | License# 2214
1113 Hamilton Street | Roanoke Rapids, NC 27870

Report Date: 2/17/2009

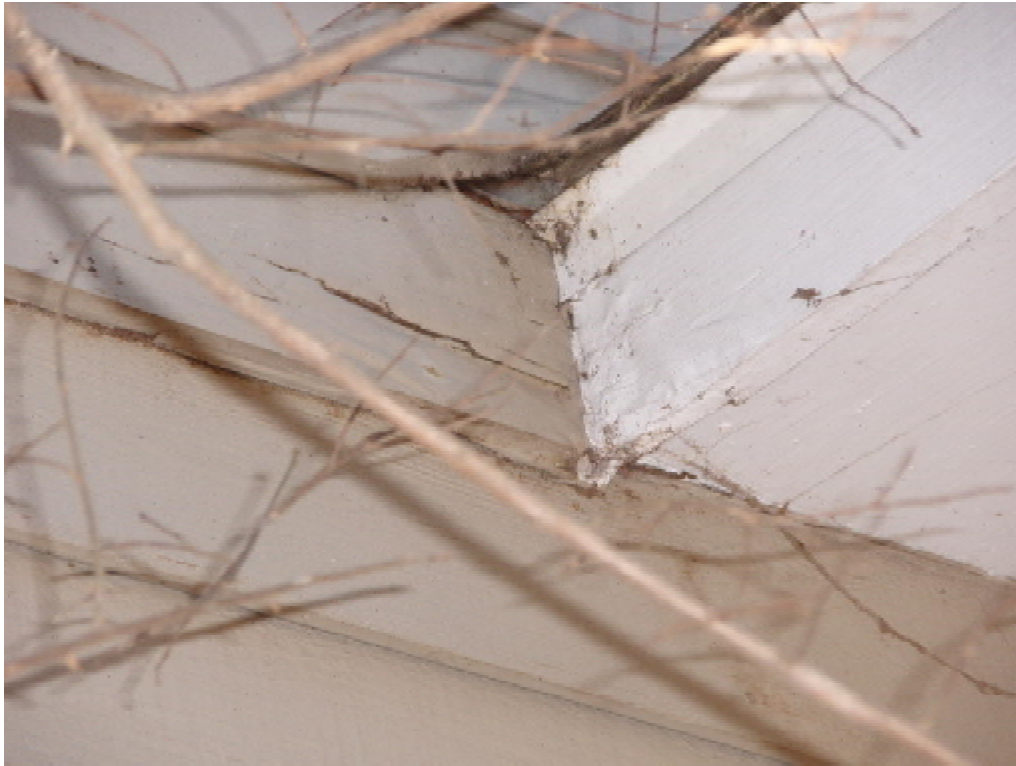
EX2

Moisture damage to exterior is present at the following locations:
 near left front fascia at garage, chimney trim midway, lower wall at back & front porch roofs,
 Repair and/or replace as needed.

Exterior
moisture damage near garage

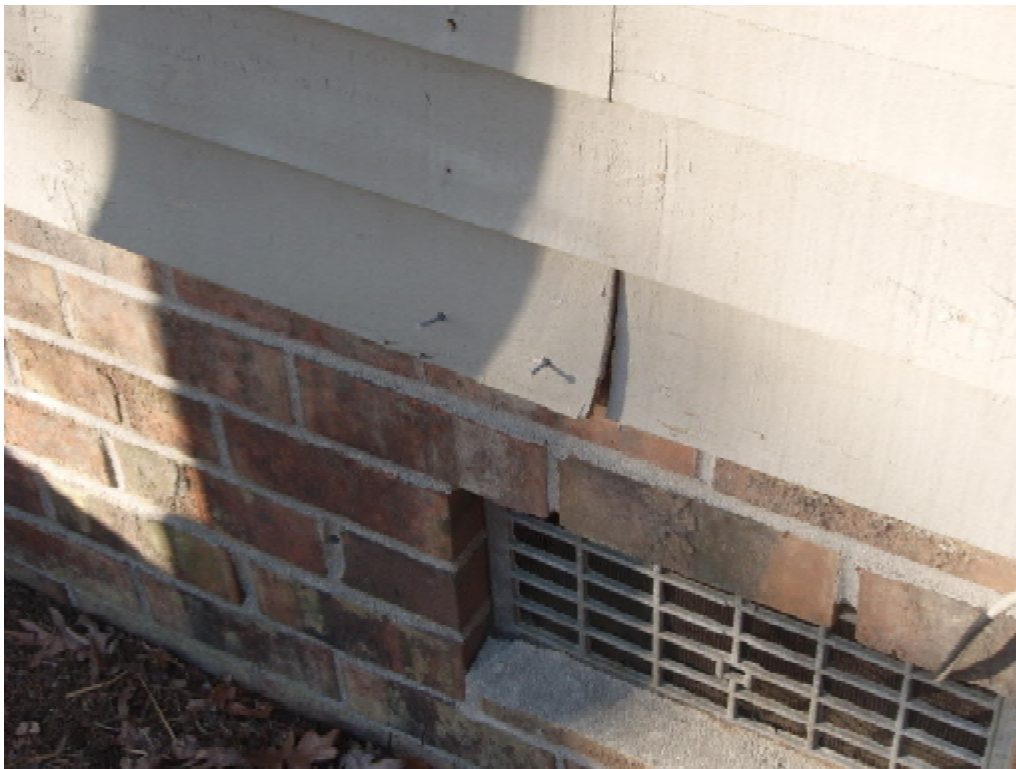
EX8

Various locations: Siding is loose and weathered at lower walls.

Exterior
loose boards

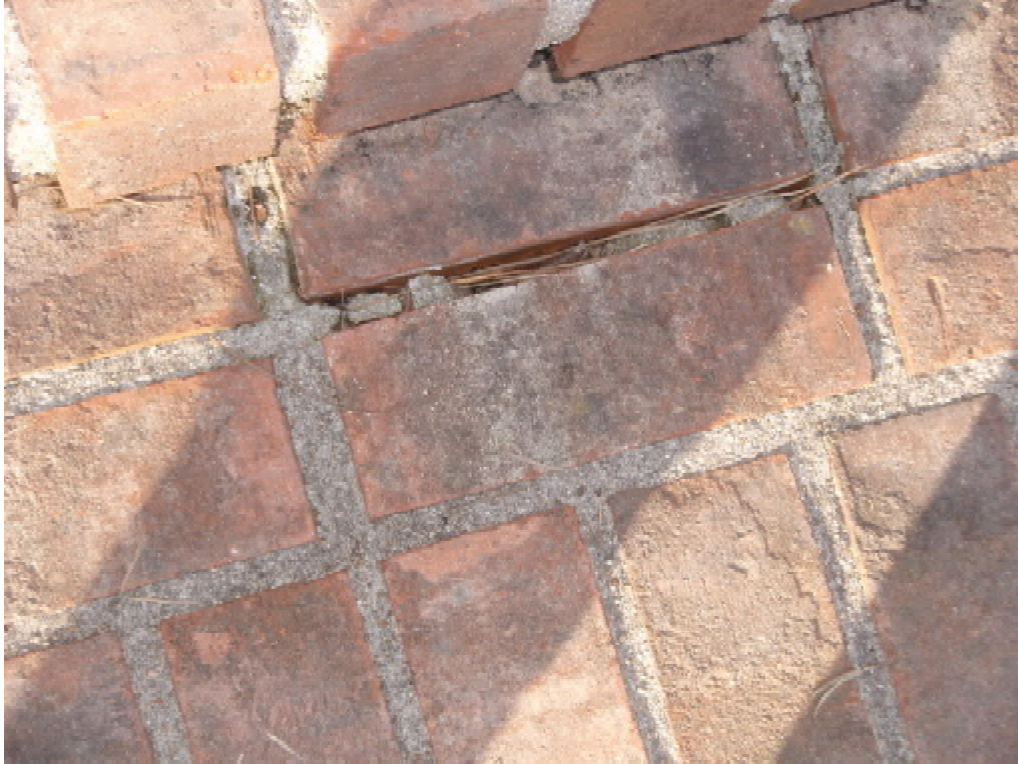
GD3

Front Steps have cracks and/or gaps. Seal cracks and gaps to avoid moisture intrusion and subsequent damage from freezing.

**Grounds & Drainage
cracks & gaps at front steps**

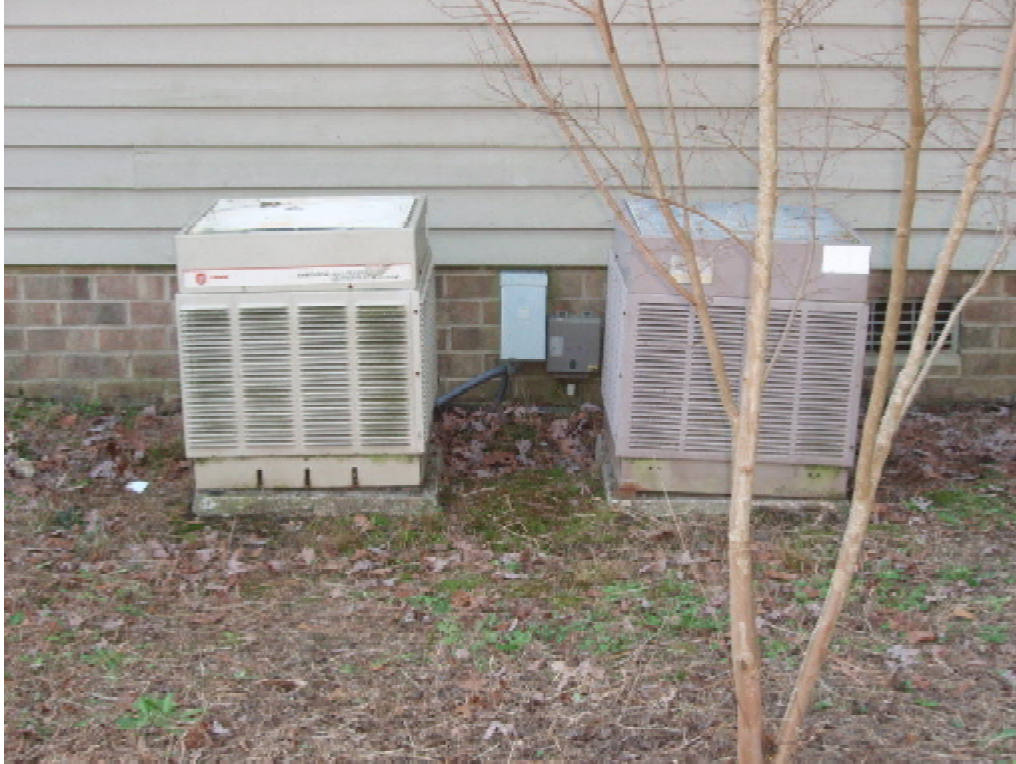
HC4

Compressor: Insulation has deteriorated at refrigerant line. Repair insulation to maintain efficiency of units.

HVAC
compressor units

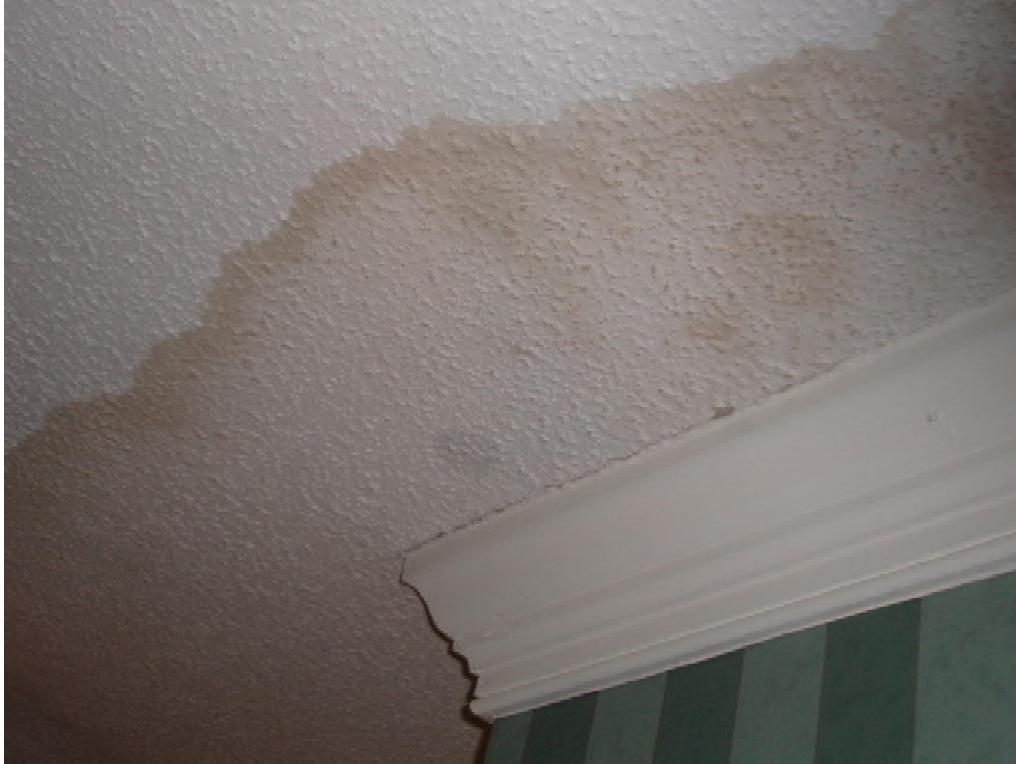
B7

Active leak from upstairs plumbing; water leaking from ceiling. Repair leak and ceiling as required.

Bathroom
stains at 1/2 bath ceiling

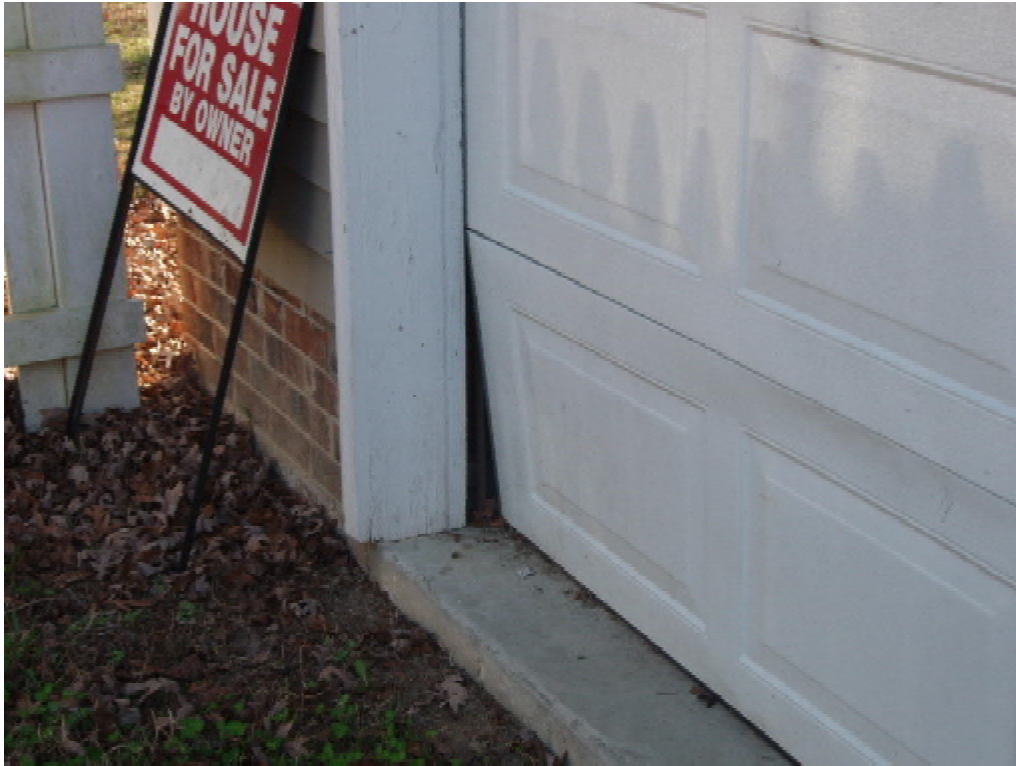
GC6

Garage door is off track: Repair door as needed.

Garage & Carport
garage door of tracks

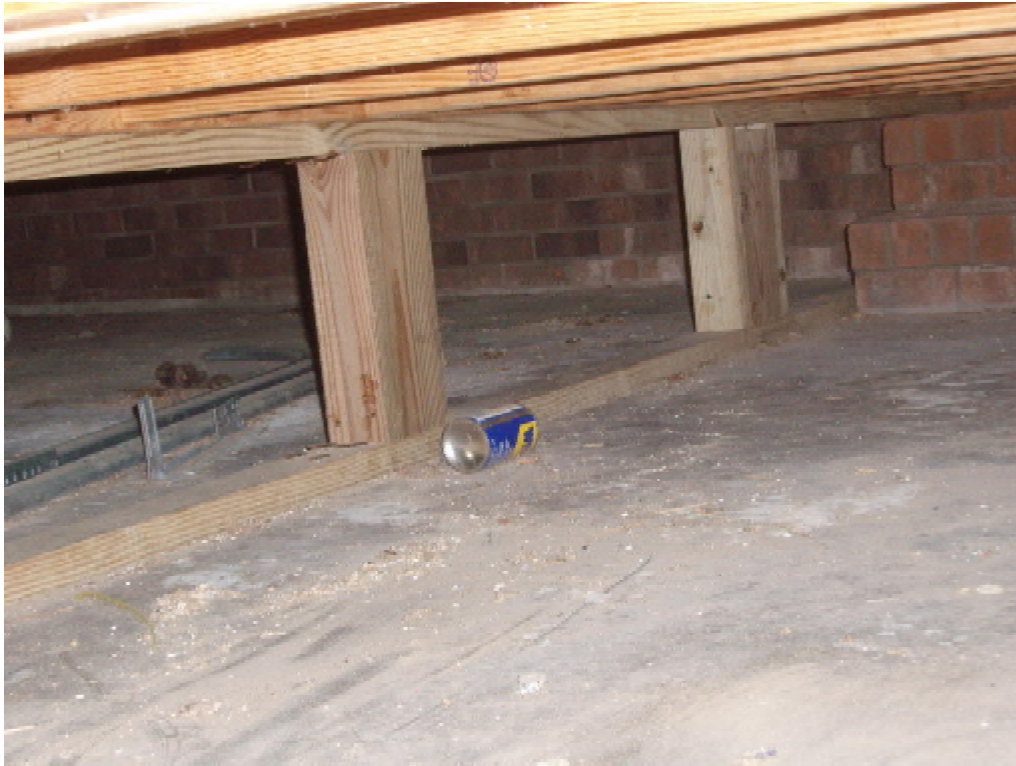
F5

- Additional rooms added on the right side are supported by wood 4x4s over the existing garage floor. This type of floor system support may not meet current building codes. Contact the code inspector and/or a building contractor for**

Foundation
right room addition supports
